# I-95/I-85 INTERCHANGE ROADWAY SAFETY ASSESSMENT

Final Report  
March 2013

# I-95/I-85 Interchange ROADWAY SAFETY ASSESSMENT

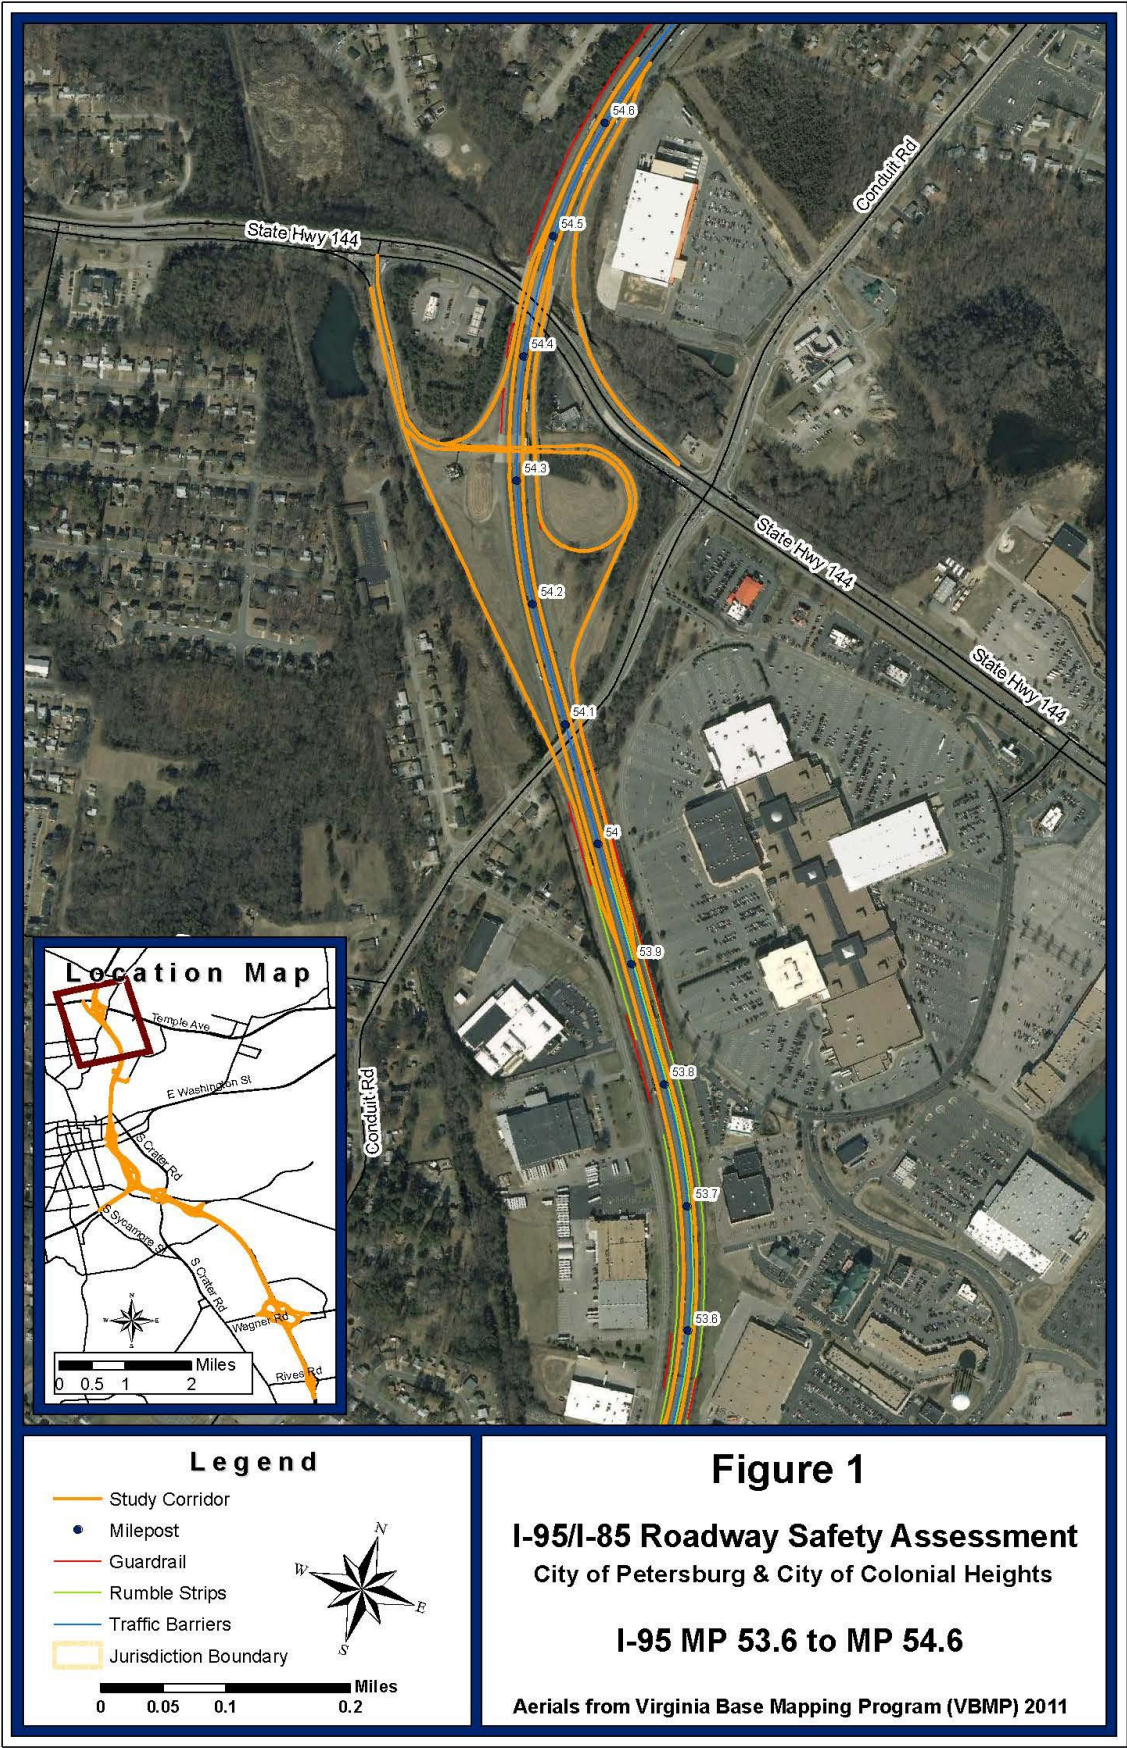
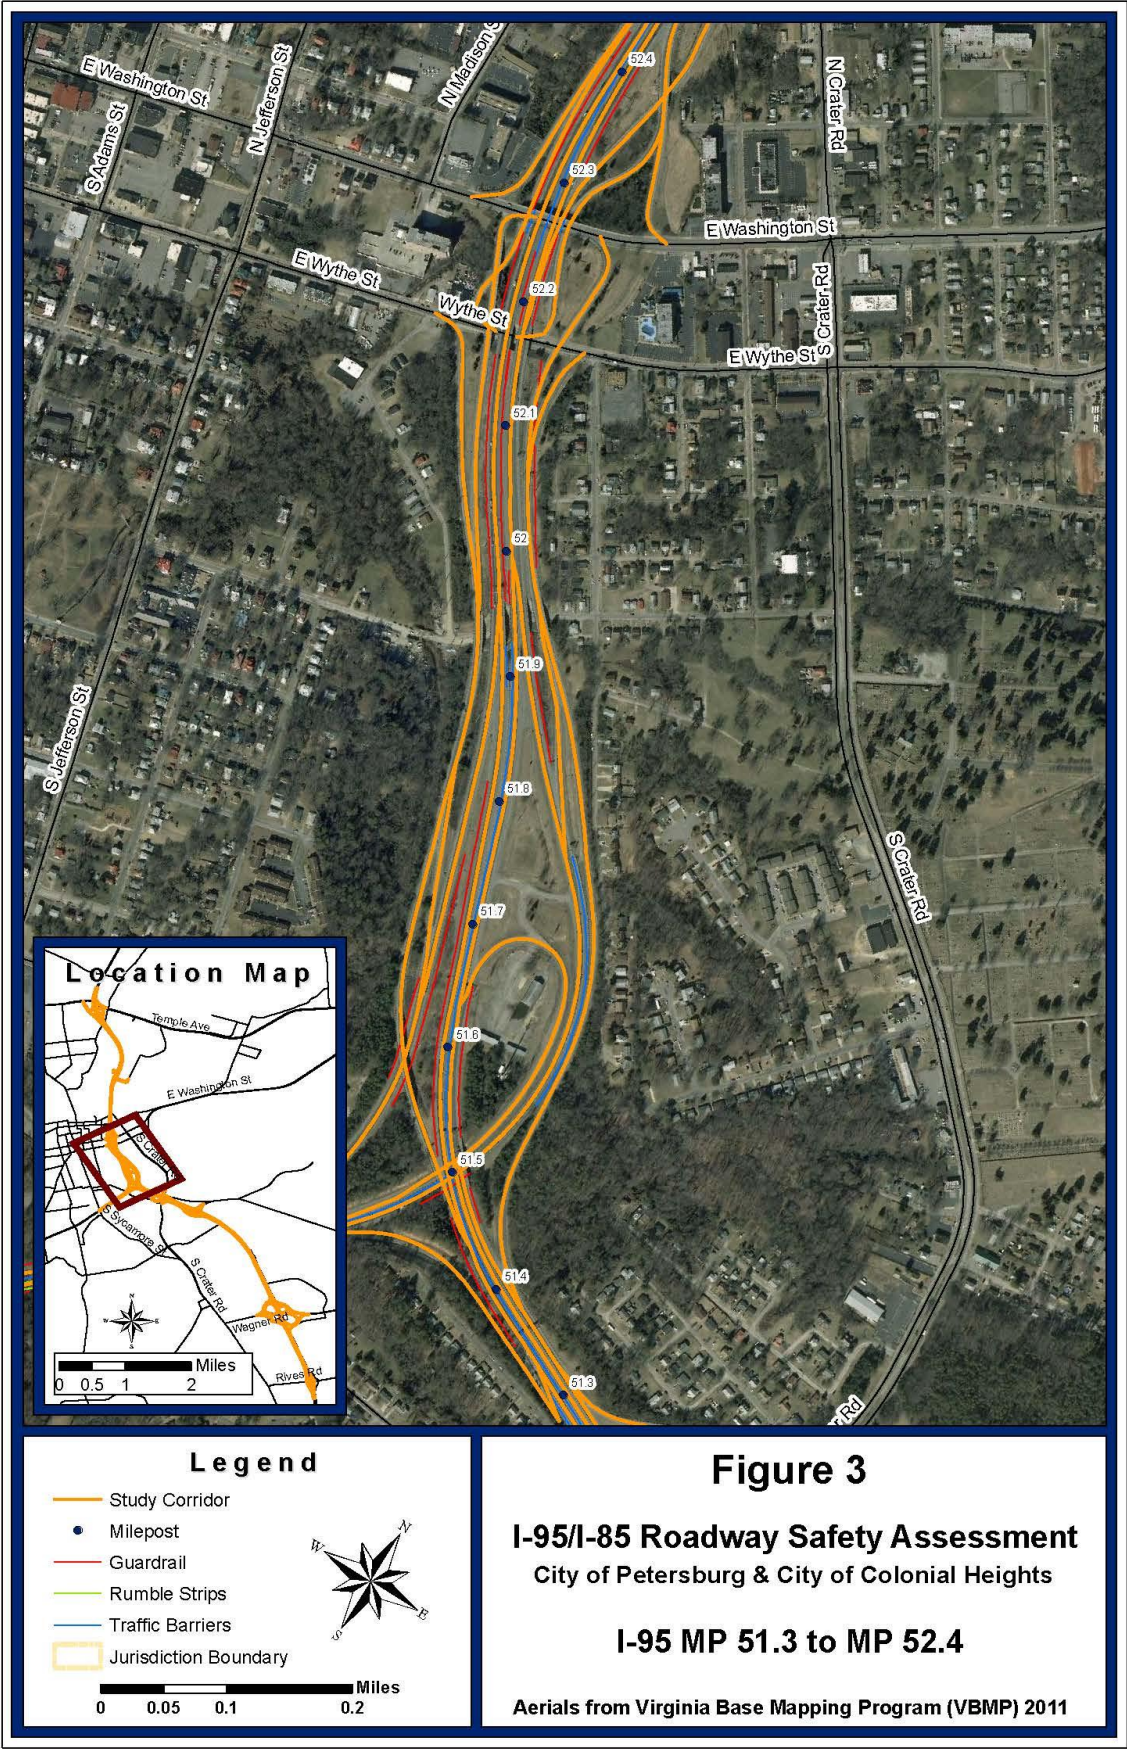
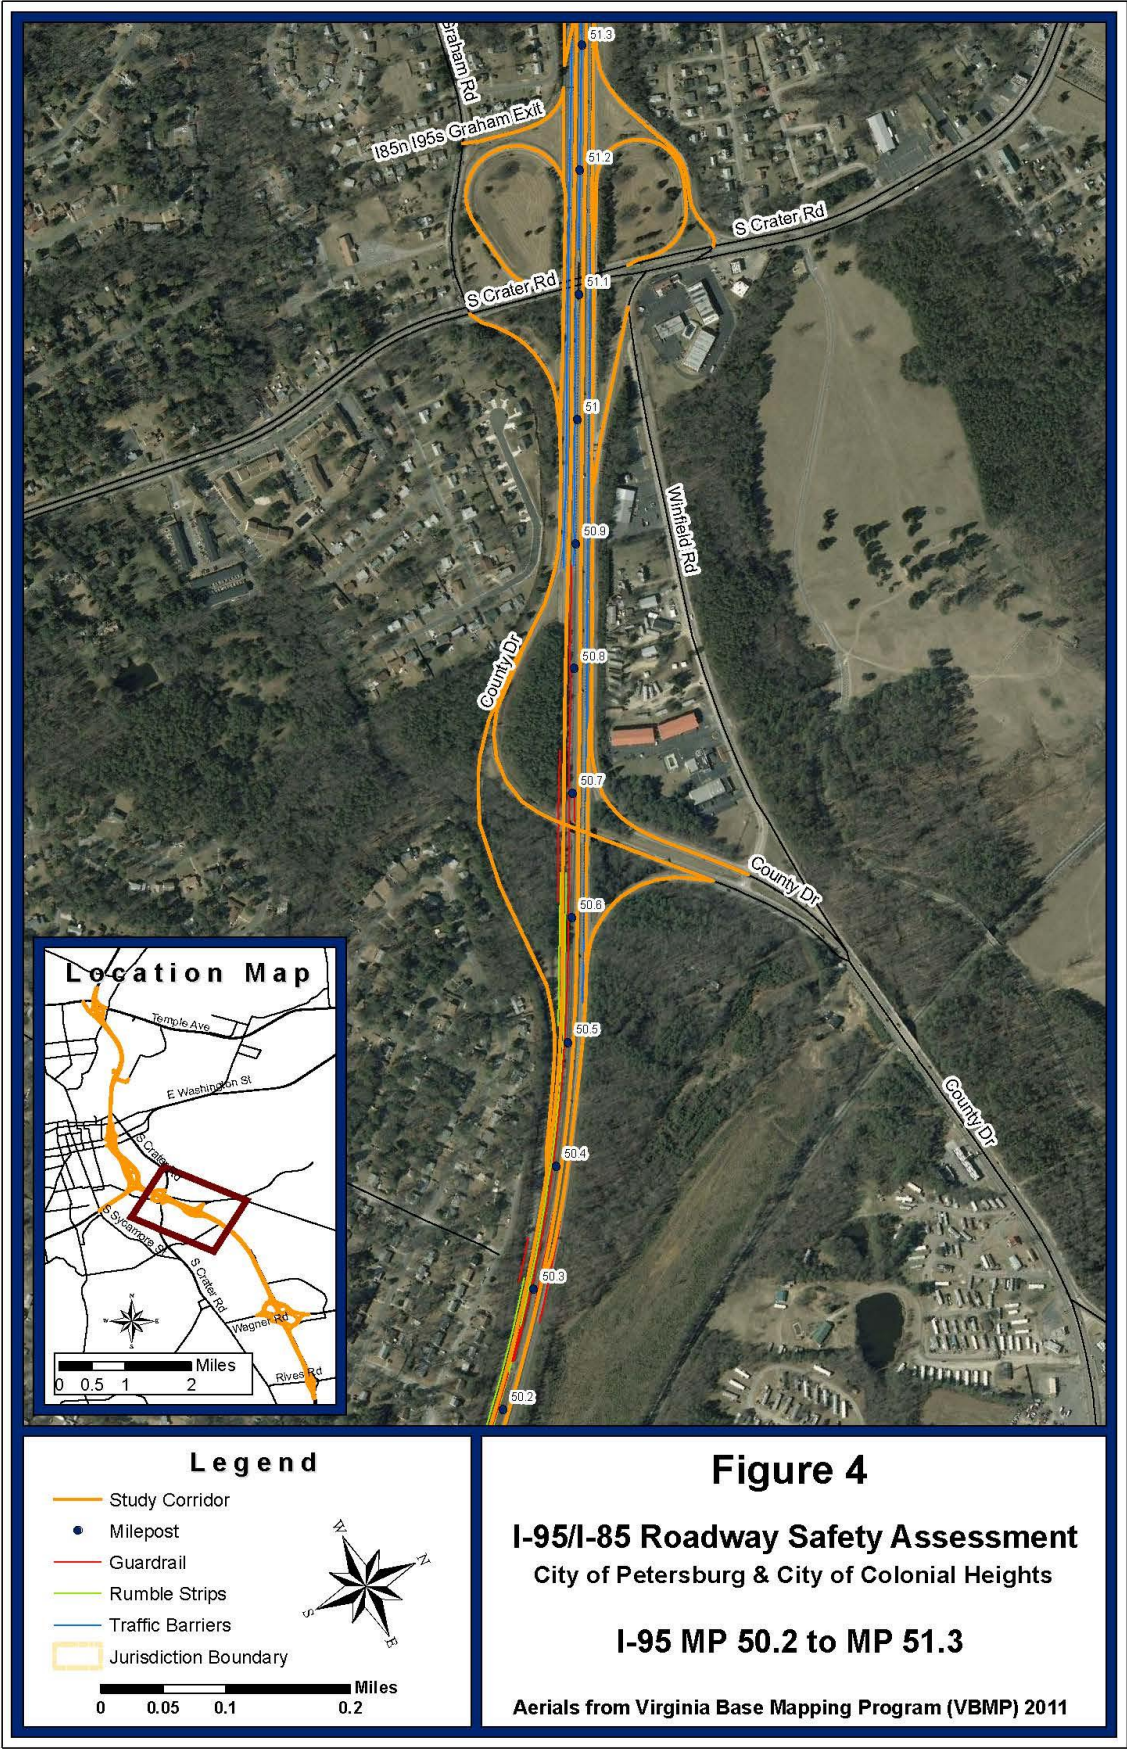
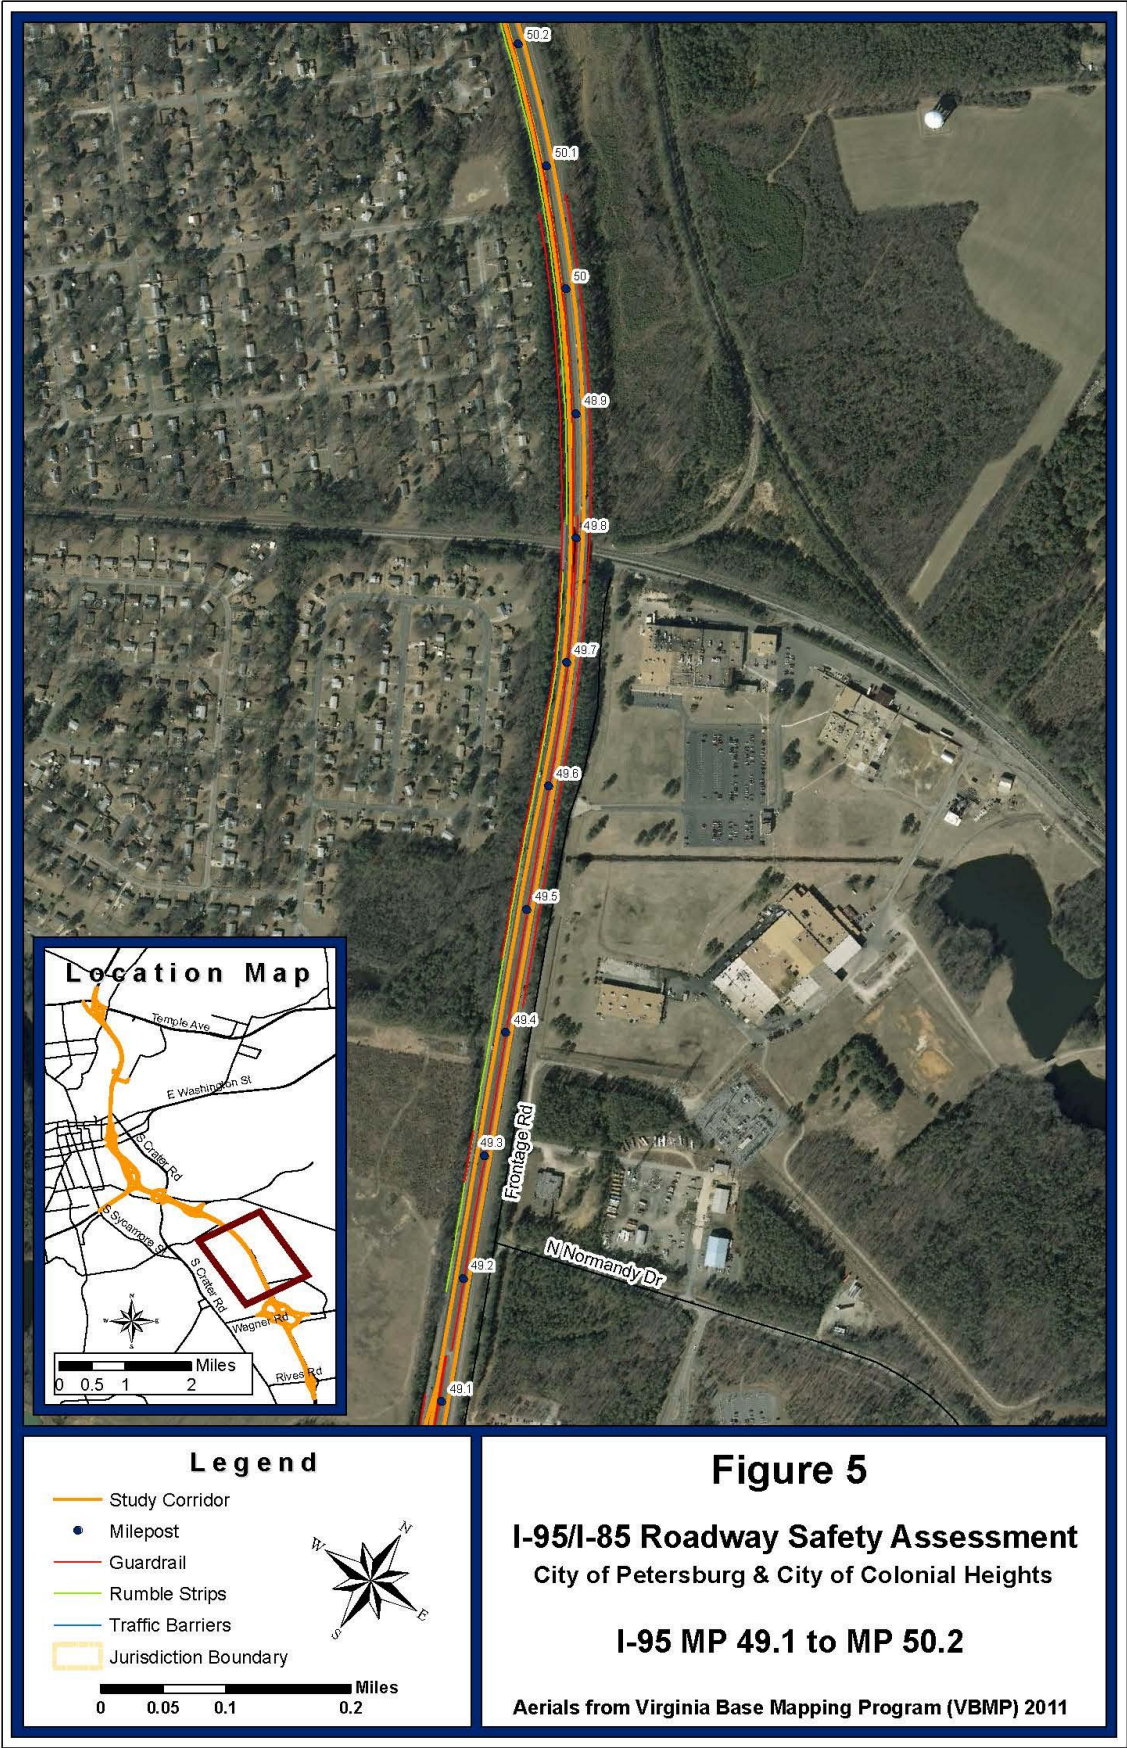
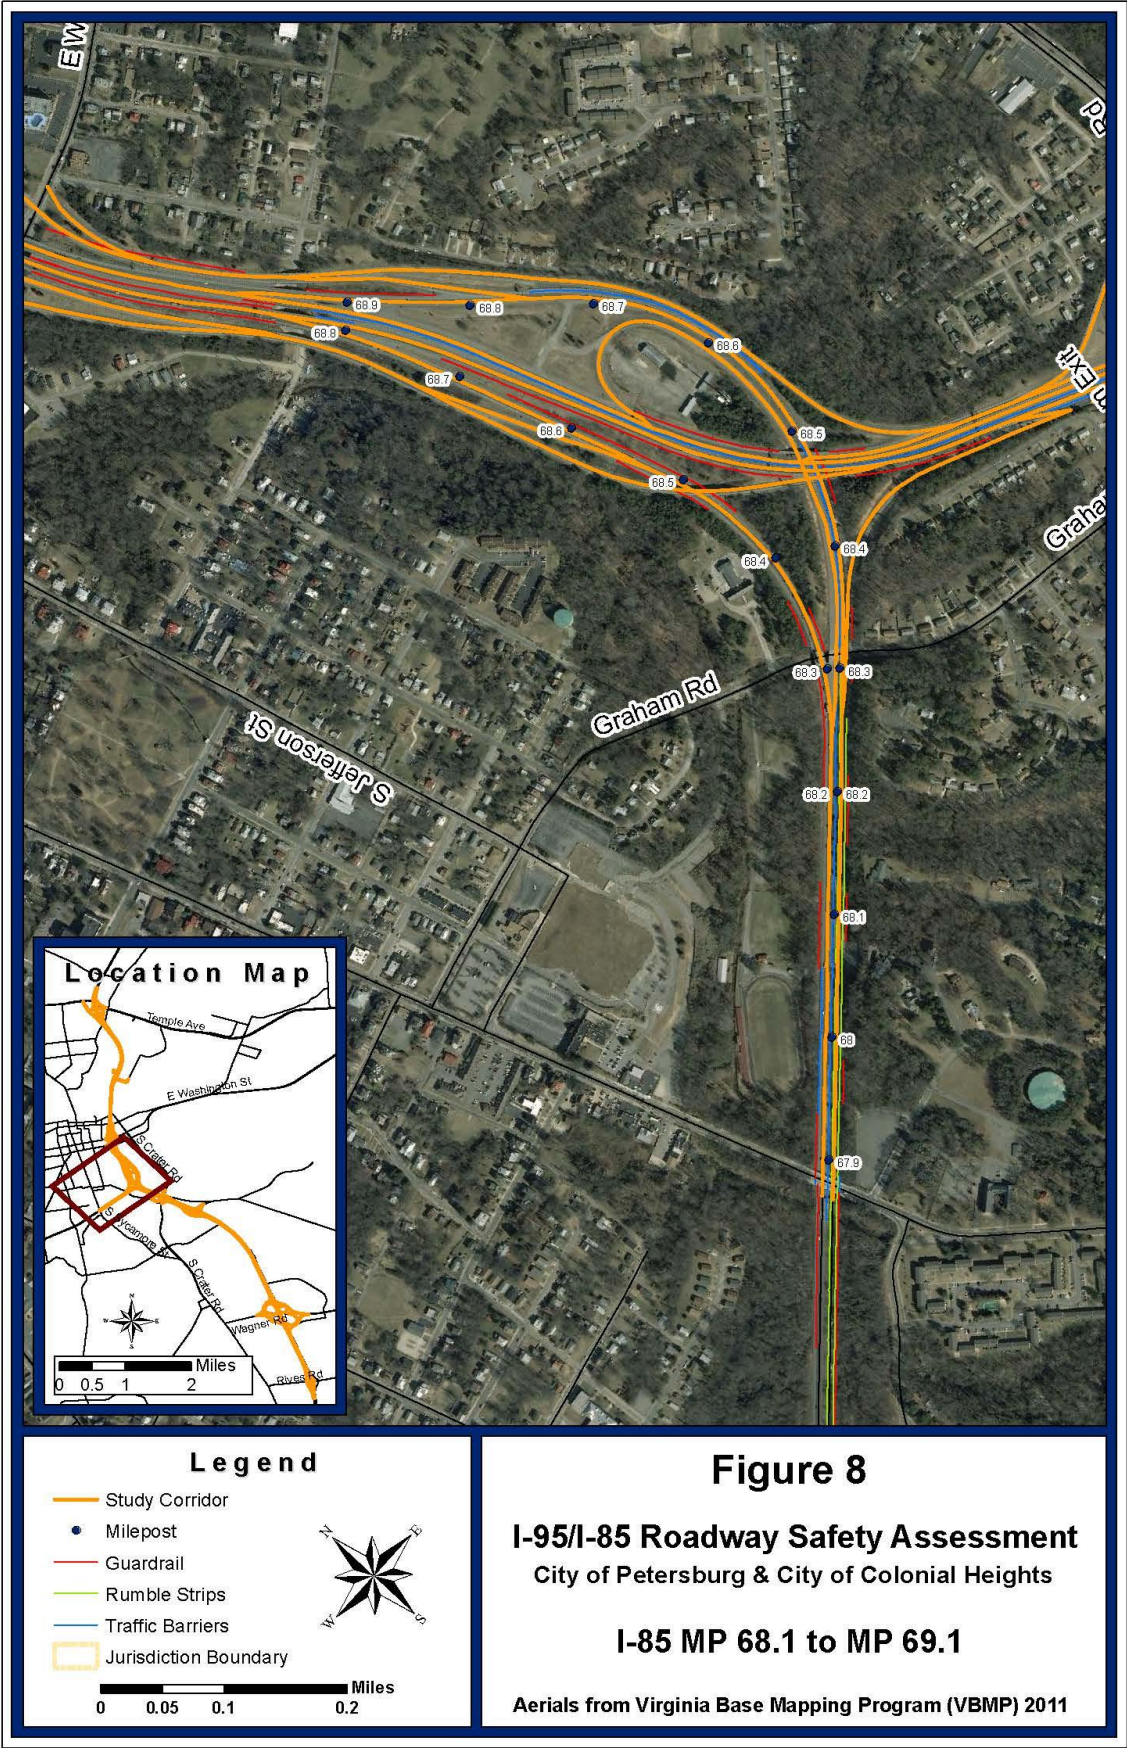
The following sections of this report detail the existing roadway conditions throughout the corridor. **Figure 1** through **8** above show the existing locations of guardrail, rumble strips and traffic barriers relative to the mileposts. These roadway properties and others will be discussed throughout this report and locations described throughout reference the mileposts in these figures.

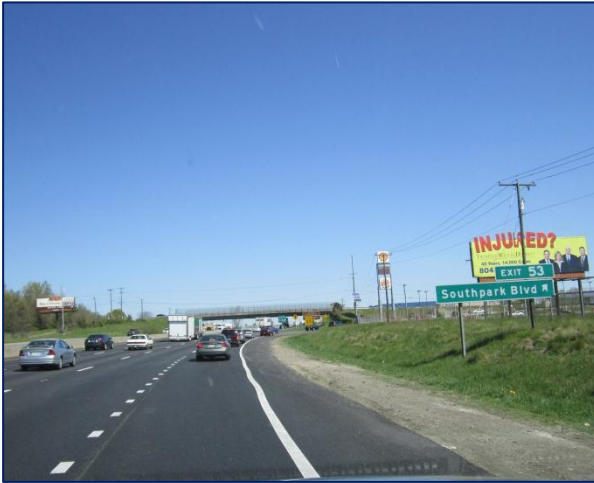
**Photograph 1: I-95 Northbound Off-Ramp to Southpark Boulevard – Midday Queue (Looking North)**

- VDOT has received numerous reports of congestion and queuing on ramps throughout the study corridor. Congestion was observed during the field review conducted on Tuesday, March 27, 2012 on the I-95 northbound off-ramp to Southpark Boulevard during midday (between 11:30 AM and 12:30 PM). **Photographs 1** and **2** shows vehicles queued on the off-ramp back to the I-95 northbound mainline.

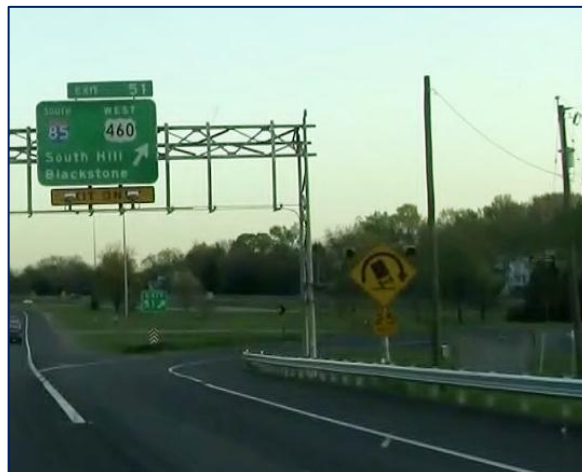
**Photograph 3: Continuous Flashing Beacons on Truck Rollover Warning Sign**

The continuous flashing beacons on the Truck Rollover Warning (W1-13) sign on the I-95 northbound off-ramp to I-85 southbound (milepost 51.7) were observed to be nonfunctioning during the field review conducted on March 27, 2012. This sign is shown in **Photograph 3**. Replacing the continuous flashing beacons are recommended as part of the corridor-wide improvements.

- Replace the nonfunctioning continuous flashing beacons on the Truck Rollover Warning (W1-13) sign on the I-95 northbound off-ramp to I-85 southbound.

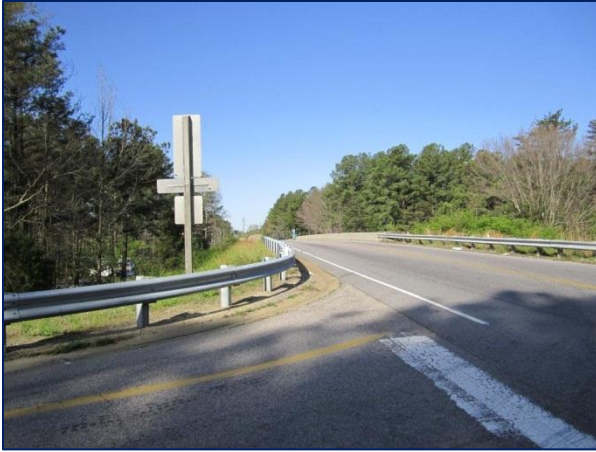
**Photograph 5: I-95 Northbound Ramp at Rives Road – Looking to the West**

- The Rives Road interchange has been identified to have insufficient sight distance at the ramp intersections on Rives Road. Sight distance looking across the bridge over I-95 from either ramp is negatively impacted by the bridge abutments and poses as a safety issues. This issue will be furthered compounded with potential traffic growth through the study area.
- **Photograph 5 - 8** were taken at the stop bars of the northbound and southbound off-ramps to Rives Road show and show the reduced sight distance.

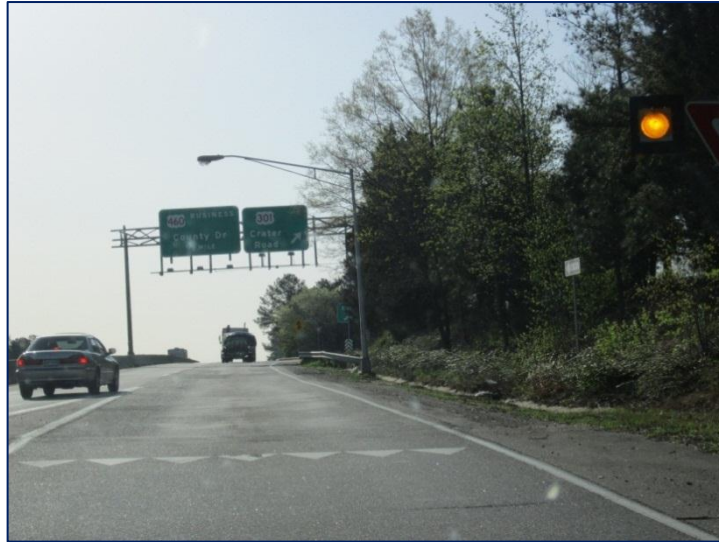
**Photograph 10: Northbound I-85 to Southbound I-95 Weave**

The yield condition on the I-85 northbound off-ramp to I-95 southbound creates a safety issue due to the short weaving segment, steep uphill grade, and percent of heavy vehicles making this movement.

- Fixed object – off road (7)
- Sideswipe – same direction (1)
- A yield sign with continuous flashing beacons exists on the right shoulder of the I-85 off-ramp; however, it was observed that vehicles merging from the I-85 off-ramp onto the I-95 CD road frequently failed to yield. VDOT installed the yield pavement markings (shark's teeth) as a short-term countermeasure; however the safety concern still exists.

- Reconfigure the I-95/I-85/Route 460 interchange to mitigate the deficient weaving movement at this location. A possible solution is provided in the Long-Term Concepts section of this study.

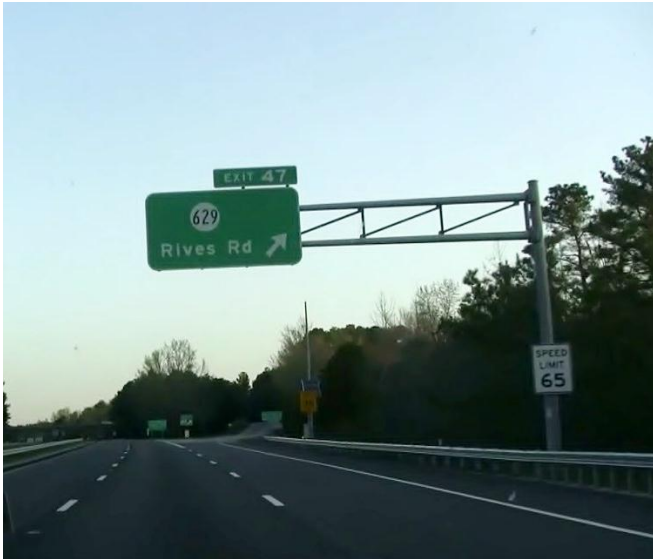
Located at MP 47.4

## OVERHEAD SIGNS WITHOUT LIGHTING I-95 NB
